# Infrared Services/Thermographic Surveys

**GOODALL INFRARED SERVICES**

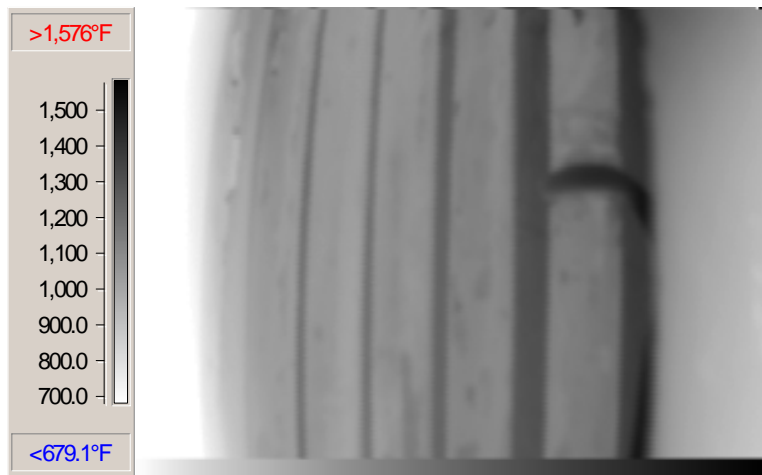
Black is hot in this infrared image of southeast end of east wall

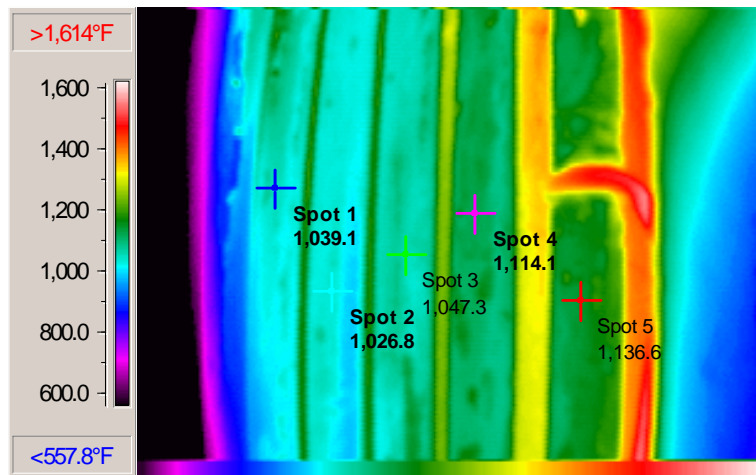
Color infrared image of tubes with temperatures of five tubes on the east wall, taken from southeast inspection port

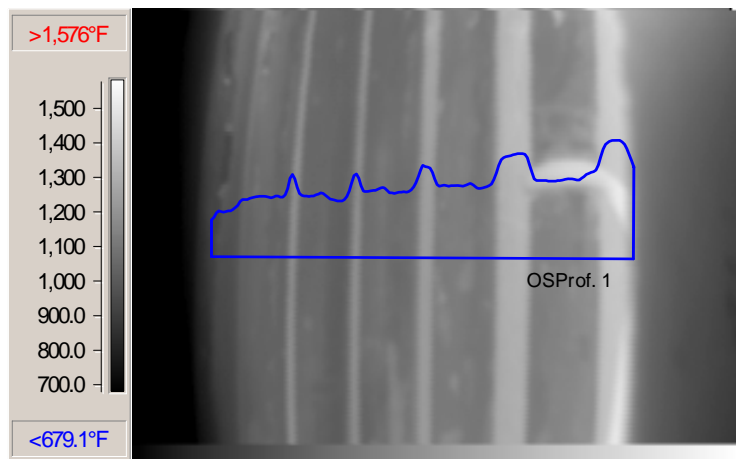
Line scan through tubes on the east wall.

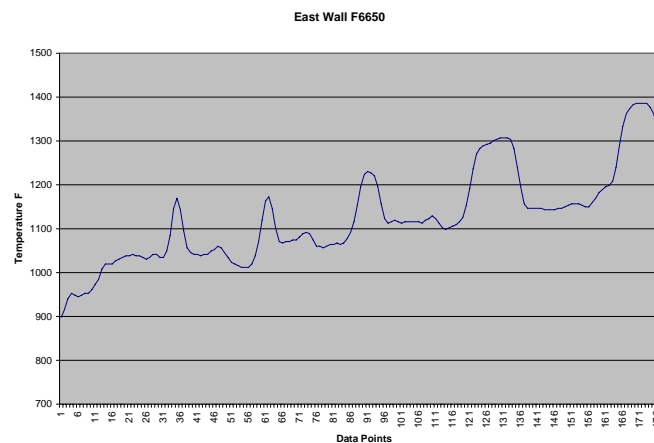
Temperature profile: tubes are the lower values, peaks are wall temperatures.

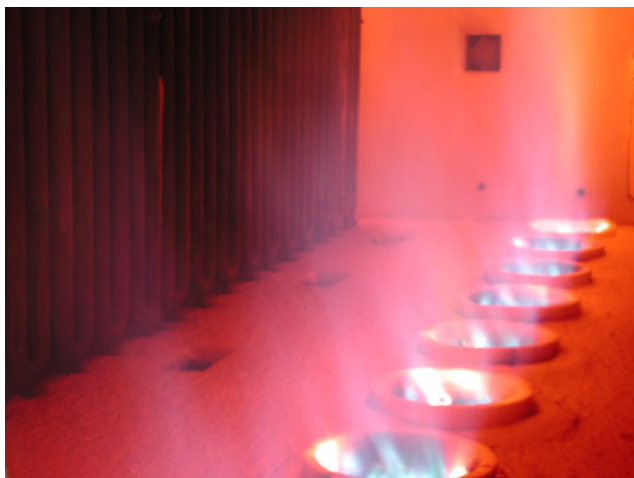
Color image of east wall, south wall and burners

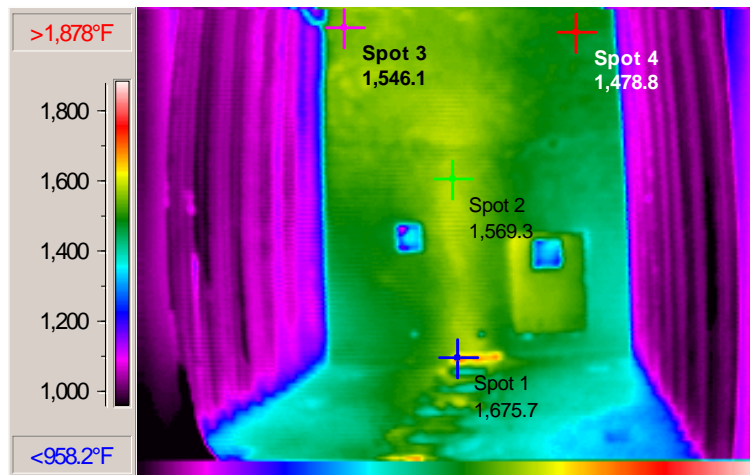
Infrared image taken from northwest inspection port. Several temperatures were taken of the wall and the south most burner.

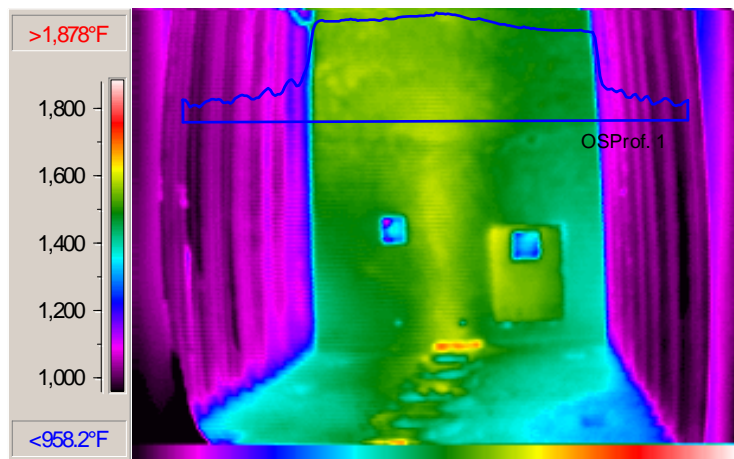
Line scan taken through east wall tubes, south wall above inspection ports and west wall tubes, southend

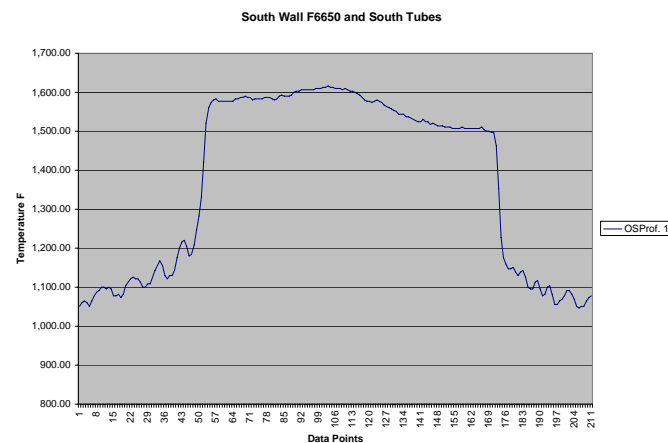
Profile generated from image at the left

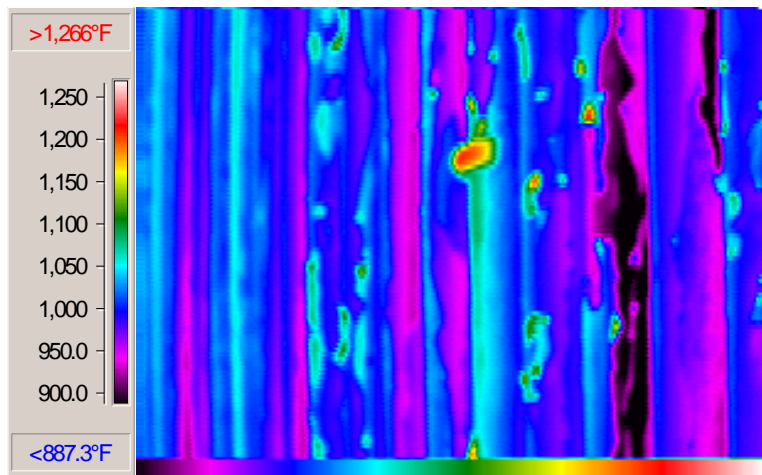
Infrared color image of center TI on west wall taken from northeast inspection port

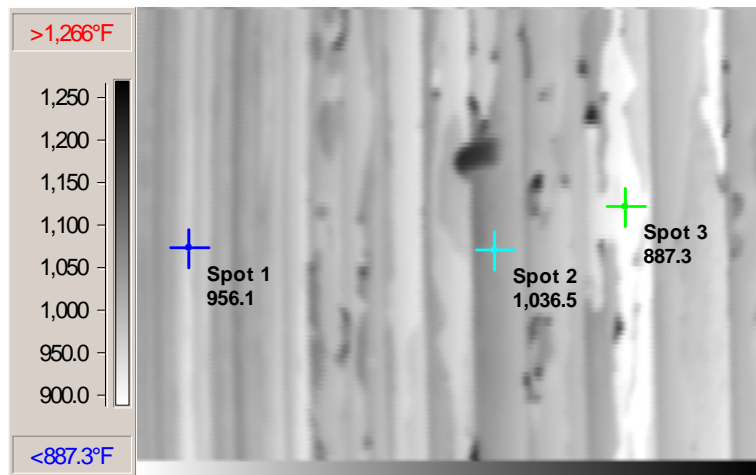
Black is hot in this infrared image

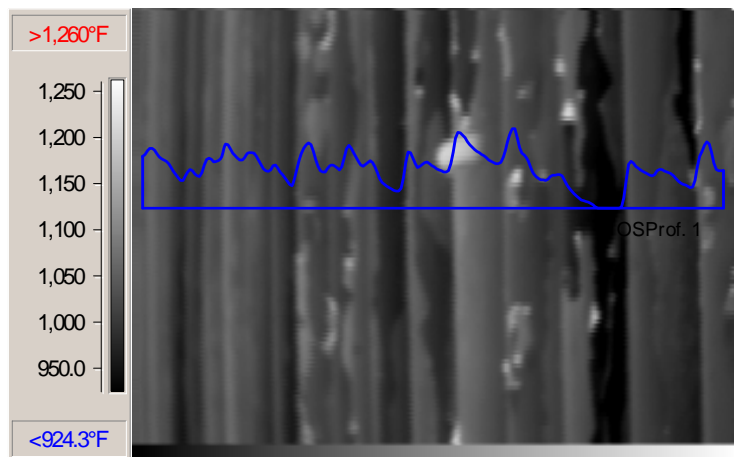
Line profile through tubes, white is hot in this image

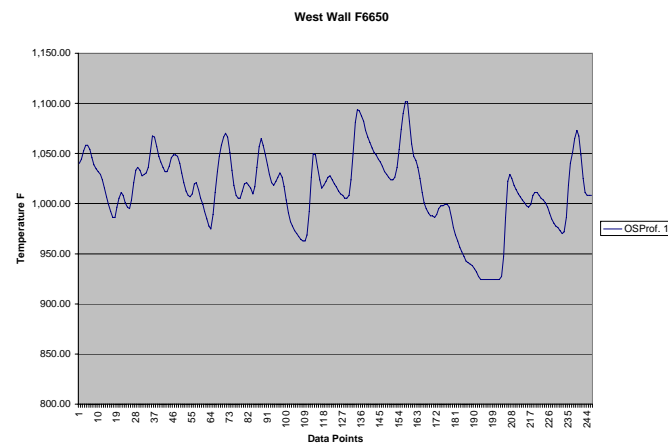
Temperature profile from the image at the left
